# San Fernando, California, Earthquake of February 9, 1971

LEONARD M. MURPHY  
*Scientific Coordinator*

*Volume I*

*Part B.* Buildings *continued*; Soils and Foundations

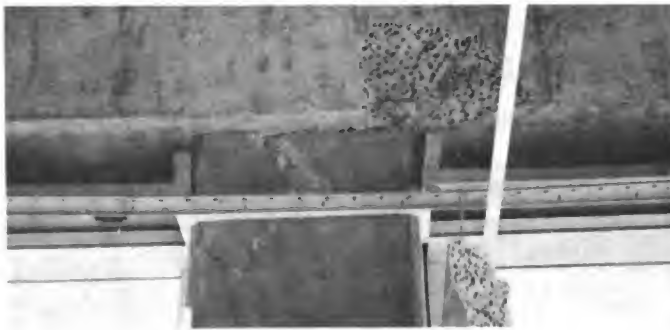
The spandrel-column detail shown in figure 18 facilitated construction (concrete pours) from the fourth floor to the roof. Major joint rotation and column or spandrel spalling coincided with areas where this detail was used (figs. 19, 20, and 21).

Figure 19.—Bank of California. Spalled lightweight concrete on fifth-floor spandrel. Note also chipped concrete on left side of column. Brandow & Johnston photograph.

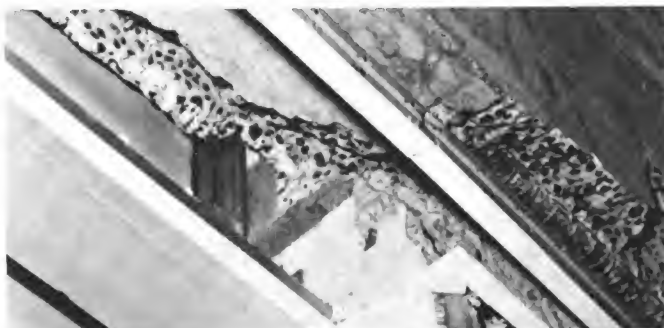
Figure 20.—Bank of California. Spalled concrete in joint zone of spandrel and exterior column. Spandrel is offset from column centerline. Little flexural cracking was evident in members on either side of joint. Note main bottom reinforcing without confining stirrups within column zone. Brandow & Johnston photograph.

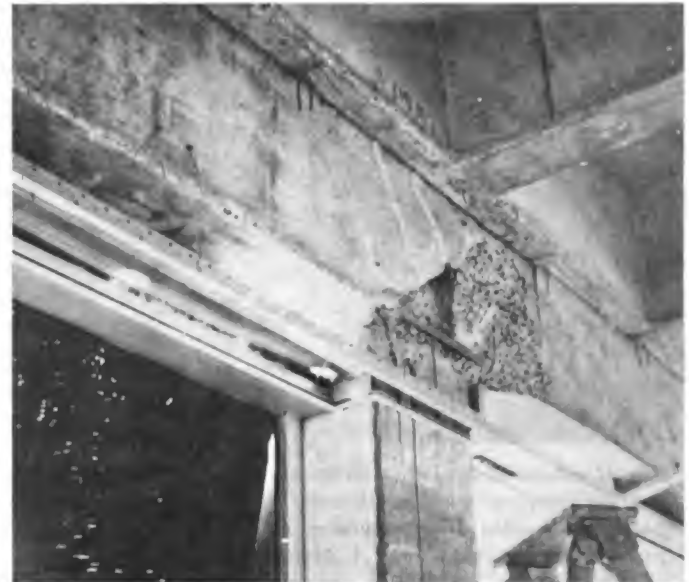
Figure 21.—Bank of California. Spalled area of spandrel beams after all cracked and loose concrete had been chipped away in preparation for epoxy repairs. Prior to this photograph, epoxy pressure grouting was already under way with an epoxy sand mortar injected at a pressure of 20 psi. Brandow & Johnston photograph.

All of the damage experienced was reparable. Repairs totaled \$44,000; \$12,000 was spent on epoxy repair of damaged concrete elements.

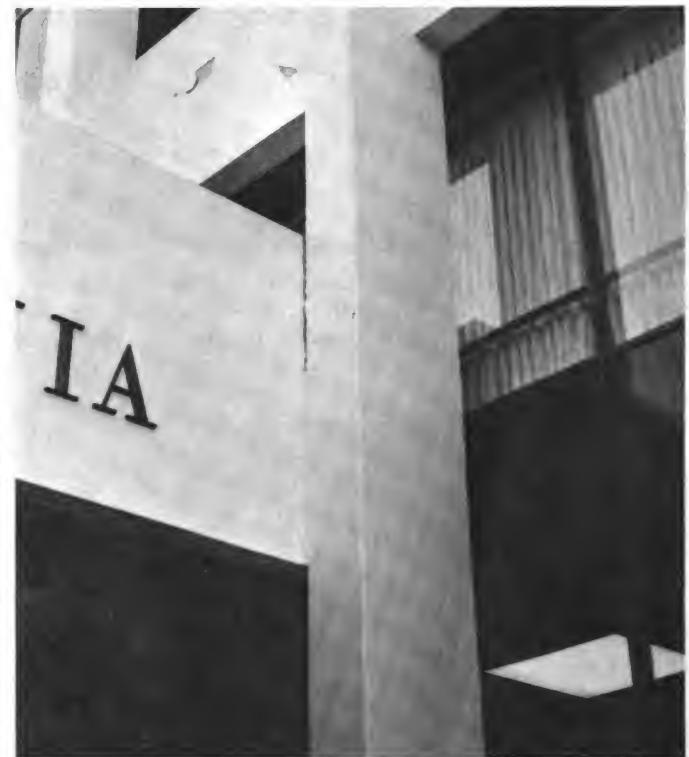
A cold joint bonded the low roof structure to the side of an east building column. This joint, not designed to be integral, sheared free during the earthquake (figs. 22 and 23). The east wall of the one-story portion also showed horizontal cracks at construction joints, but no other damage or shear cracks were seen.

Figure 22.—Bank of California. Low roof connection to office tower columns at second-floor level. Original building plans specified a seismic separation at this point, but this detail was poured monolithically during construction. Brandow & Johnston photograph.

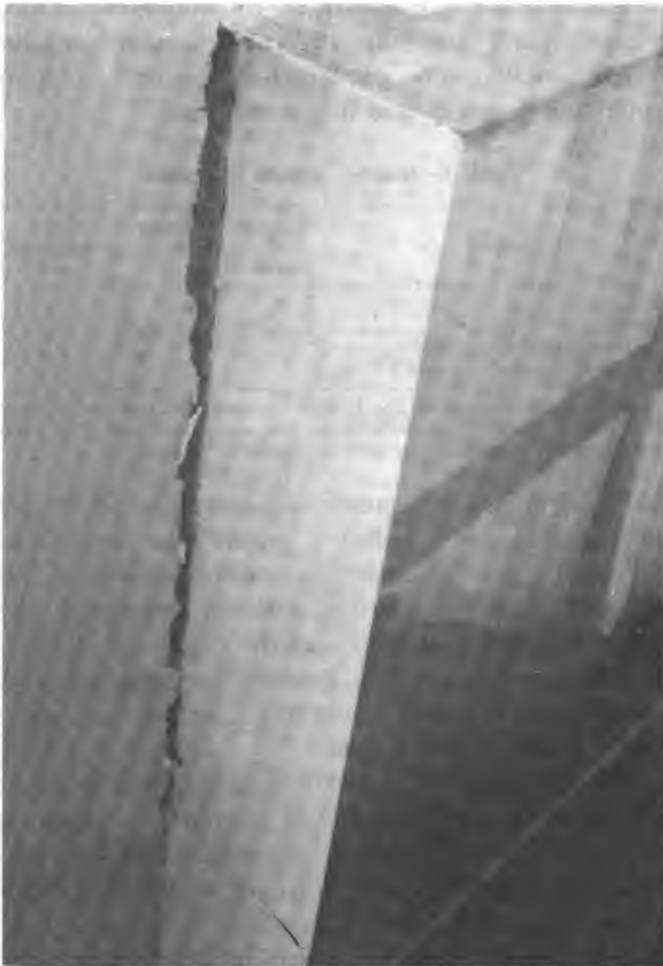
Figure 23.—Bank of California. Closeup detail of figure 22. Brandow & Johnston photograph.

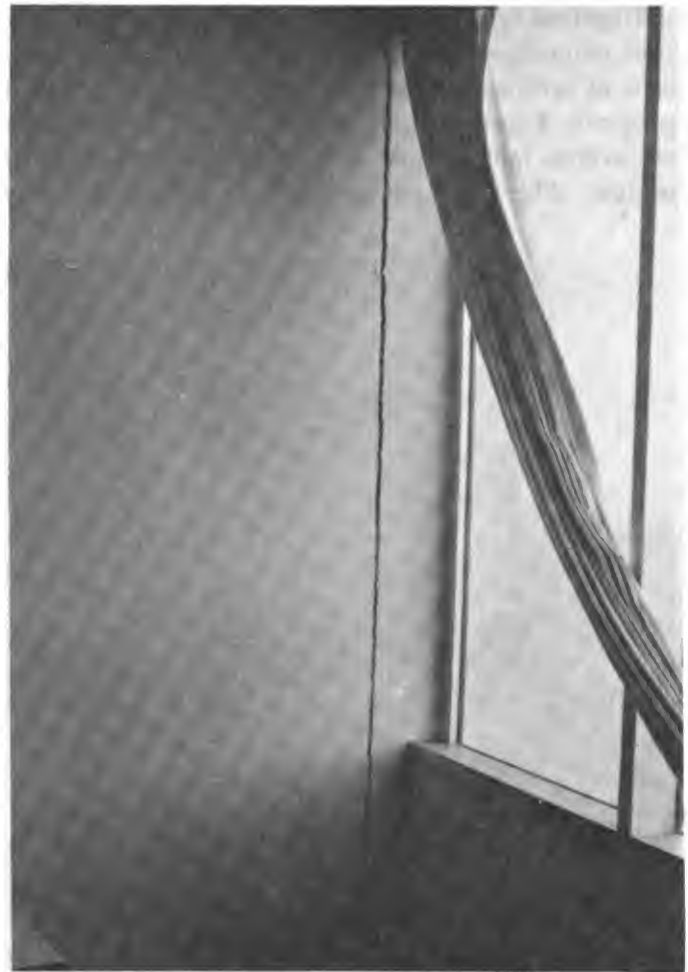
Nonstructural damage was distributed extensively between the sixth and 11th floors. Partitions running in an east-west direction pulled away from east and west exterior columns as shown in figure 24. Thus, ceiling tiles fell out. Between the third and fifth floors, some bolts on east-west spanning stairs were pulled from concrete floor beams. Partition cracking also occurred in the stairwells at these levels (fig. 25), decreasing below the fourth floor. At the second-floor level, windows shifted in the mullions on the north and south sides of the building.

Figure 24.—Bank of California. Cracking in drywall partitions provided an indication of interstory deflections. This east-west running partition separated substantially from the east exterior curtain wall. Brandow & Johnston photograph.

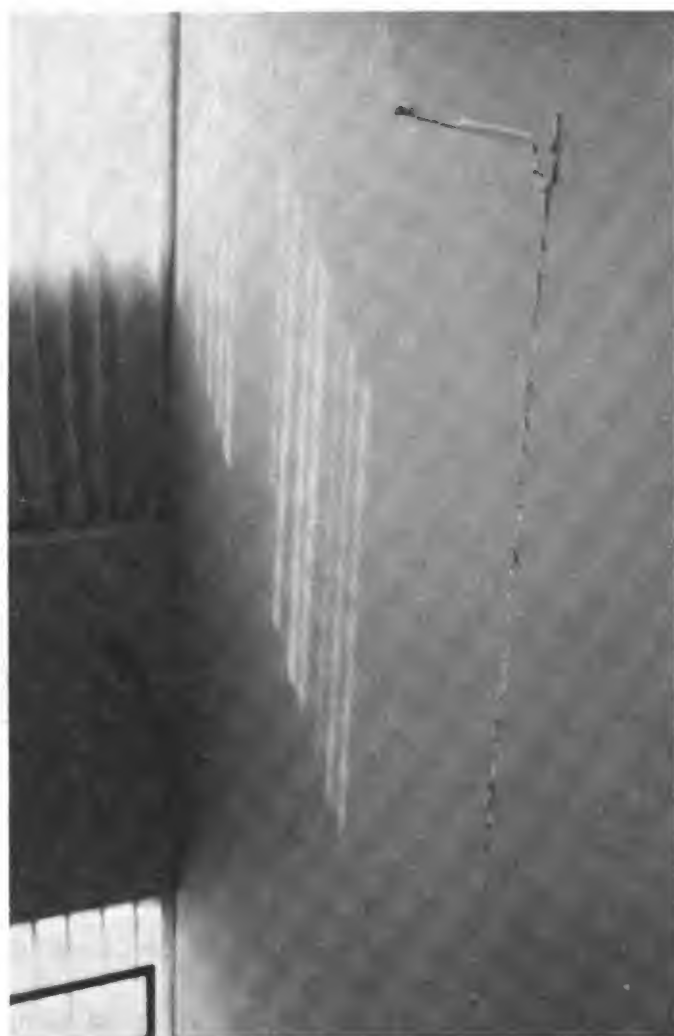
Figure 25.—Bank of California. Side walls of northwest stairwell showed signs of "working" during the earthquake. Brandow & Johnston photograph.

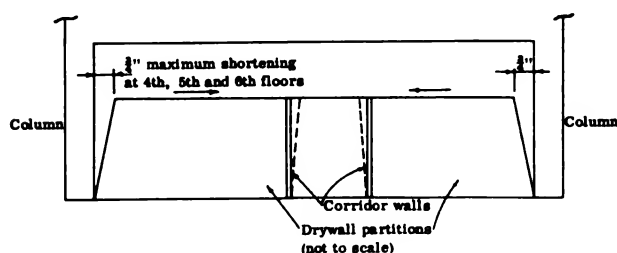
The east-west running gypsum wallboard on steel stud partitions was fastened to both the floor and suspended ceiling. As the building displaced laterally during the earthquake, racking of the partitions and shortening of the hung ceiling took place. As illustrated in figure 26, the ceiling level shortened as much as  $\frac{3}{4}$  inch. This indicated story drifts of at least  $\frac{3}{4}$  inch. Such partition and ceiling displacements were observed at the fourth, fifth, and sixth floors, and to a lesser extent at the seventh, eighth, and ninth floors.

Figure 26.—Bank of California. Shortening of transverse drywall.

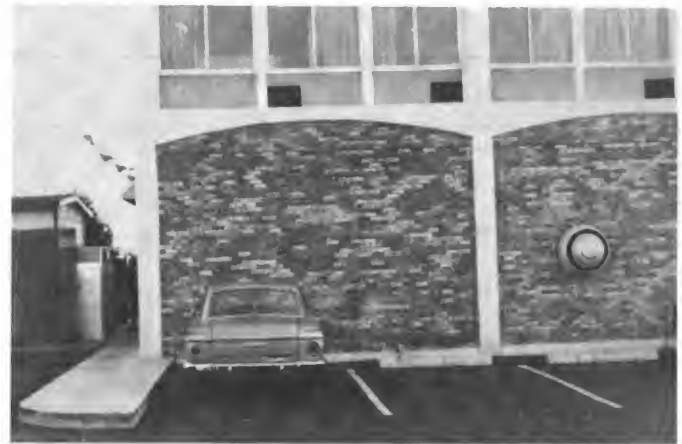
Figure 8.—Holiday Inn, Orion Avenue. East end of north side of building. Crack at second-floor beam-column joint. John A. Blume & Associates photograph.

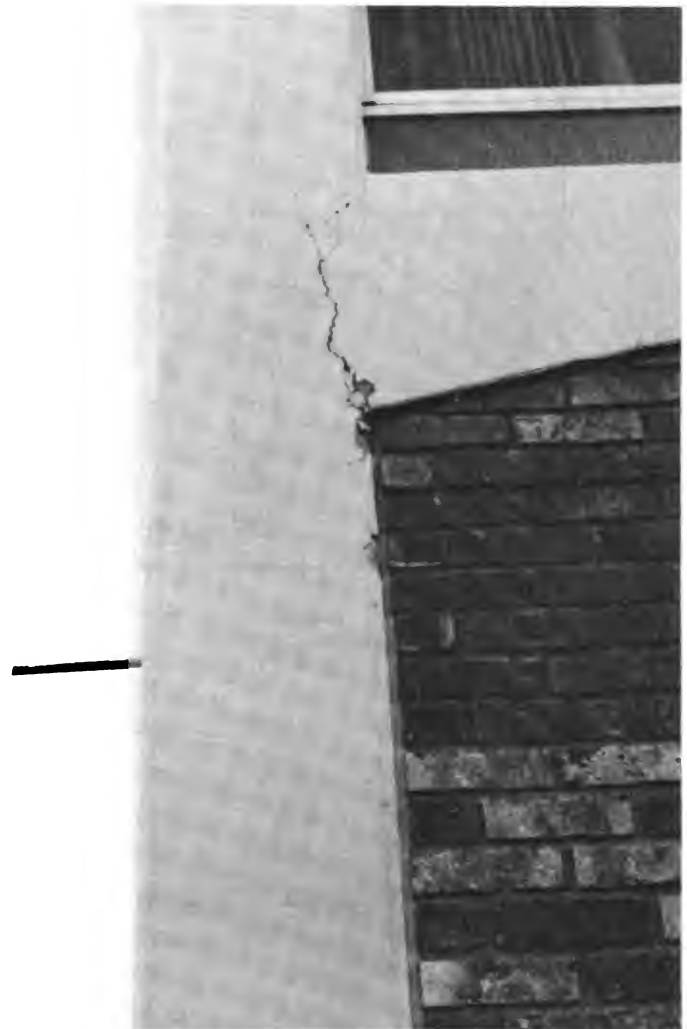
Figure 9.—Holiday Inn, Orion Avenue. Closeup view of figure 8. John A. Blume & Associates photograph.

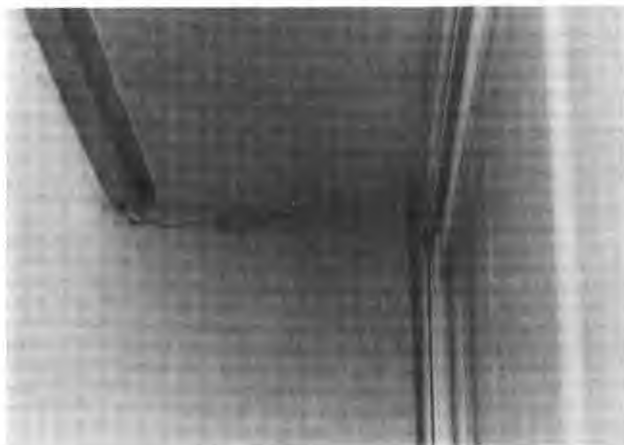
Figure 10.—Holiday Inn, Orion Avenue. Exterior spandrel beam-to-column connection. Shallow cracking at column pour joint. General Adjustment Bureau photograph.

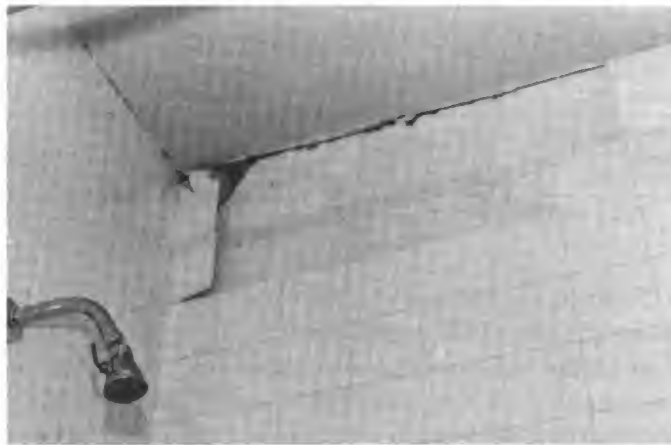
Figure 13.—Holiday Inn, Orion Avenue. Damage to tile above bathtub on second floor. John A. Blume & Associates photograph.

Some gypsum wallboard panels had to be replaced. Interior partitions required paint and new vinyl wall covering (fig. 11). Forty-five bathtubs (fig. 12) and 12 water closets had to be replaced. Bathroom tile had to be patched, grouted, or replaced in over half of the bathrooms (fig. 13). Spalling occurred at architectural concrete attached to structural concrete columns at the ground floor (fig. 14). Exterior cement plaster spalled and cracked. Windows in every room required some alignment and caulking, although none needed replacing. Doors needed adjustment.

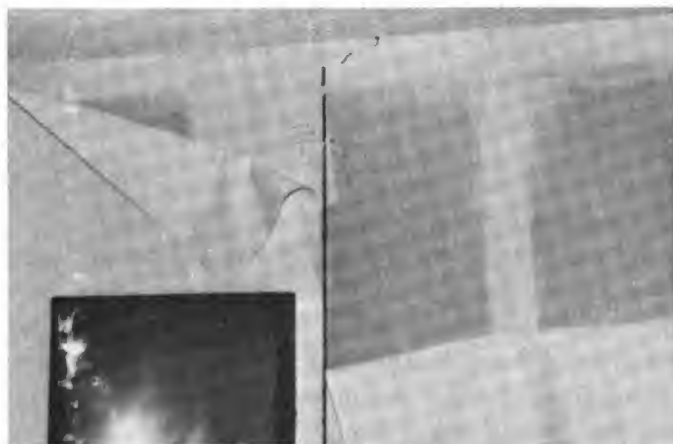
Figure 11.—Holiday Inn, Orion Avenue. Break in gypsum wallboard on second floor. John A. Blume & Associates photograph.

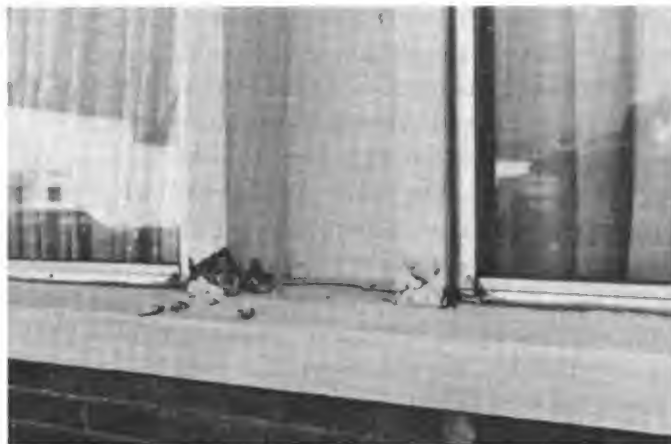
Figure 14.—Holiday Inn, Orion Avenue. Spalling of architectural concrete at first-floor column, north side. John A. Blume & Associates photograph.

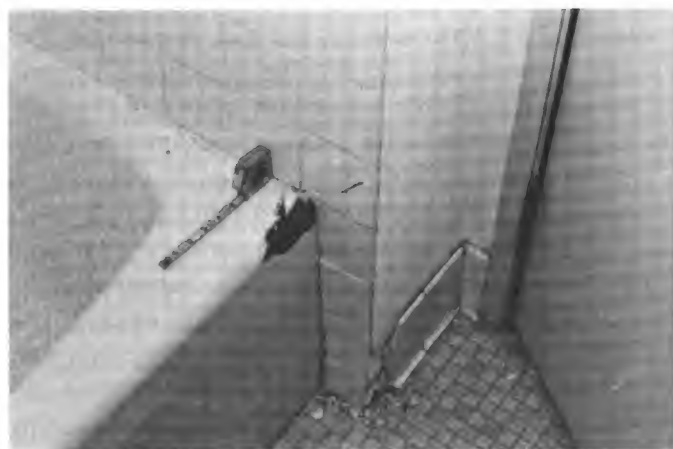
Figure 12.—Holiday Inn, Orion Avenue. Damage to bathtub at second floor. John A. Blume & Associates photograph.

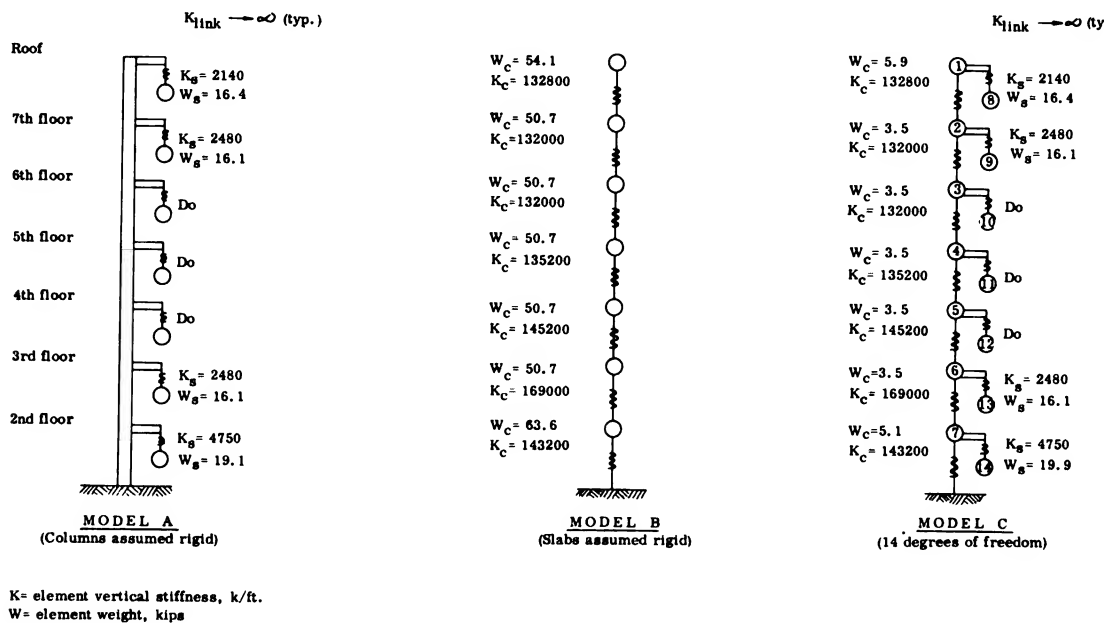
Figure 31.—Holiday Inn, Orion Avenue. Vertical response mathematical models.

The model reduced to a mutually decoupled, 7°-of-freedom slab element system when the columns are assumed rigid relative to the slabs (fig. 31, model A). For the alternate extreme of the slabs assumed rigid relative to the columns, a coupled 7°-of-freedom column system results (fig. 31, model B). Because of the coupling in the real system, these two extremes do not necessarily bound the vertical response for a given damping ratio. A 14°-of-freedom model also was analyzed by hand, using calculated representative values of slab and column element effective mass and stiffness (fig. 31, model C).

Mathematical models used in the hand-calculated analyses are shown in figure 31. Table 15 shows the results. Interestingly, all three models produce nearly the same fundamental period close to the predominant period of about 0.12 second determined from instrumental records. The rigid column, model A, and 14°-of-freedom model C yield comparable results of fourth-floor accelerations in reasonable agreement with measurements. The rigid slab model B overestimates response accelerations.

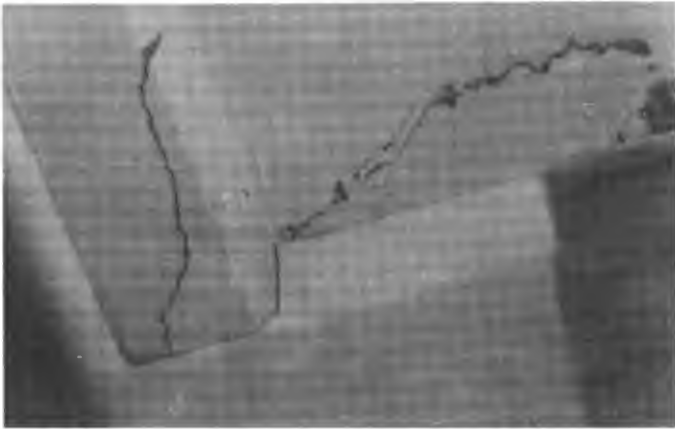
The structural repair was required at the intermediate stair landing between the first and second floors at column 1 on column line A. Cracking and spalling occurred at the slab and beam column joints. Exterior plaster had to be removed and reinforcement was exposed (figs. 8 through 12). No other damage was observed.

Figure 8.—Holiday Inn, Marengo Street. Interior view of beam and slab soffits at intermediate stair landing. General Adjustment Bureau photograph.

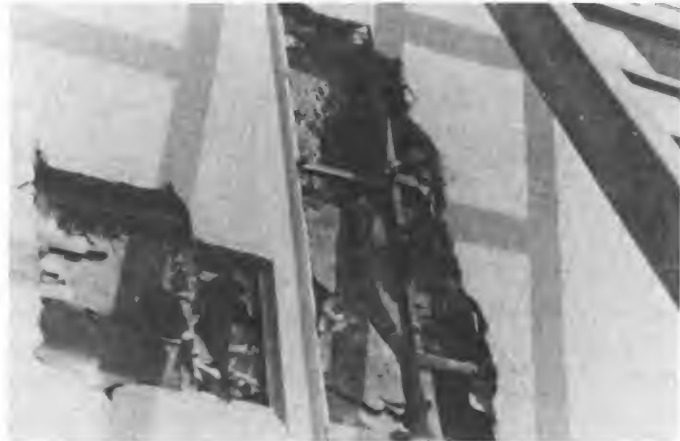
Figure 11.—Holiday Inn, Marengo Street. Closeup view of beam-column joint shown in figure 10 before all the plaster was removed. General Adjustment Bureau photograph.

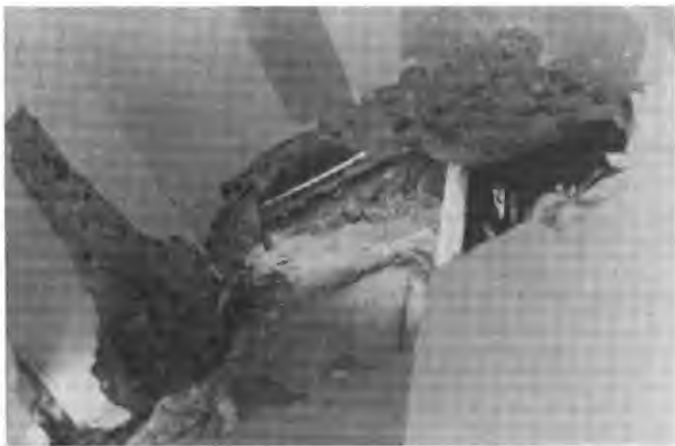
Figure 9.—Holiday Inn, Marengo Street. Same view as figure 8 after damaged concrete has been removed. General Adjustment Bureau photograph.

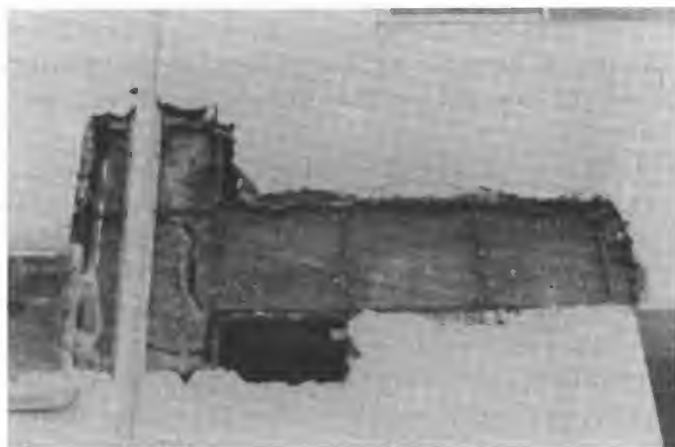
Figure 10.—Holiday Inn, Marengo Street. Exterior view of damage to beam-column joint at the intermediate stair landing. General Adjustment Bureau photograph.

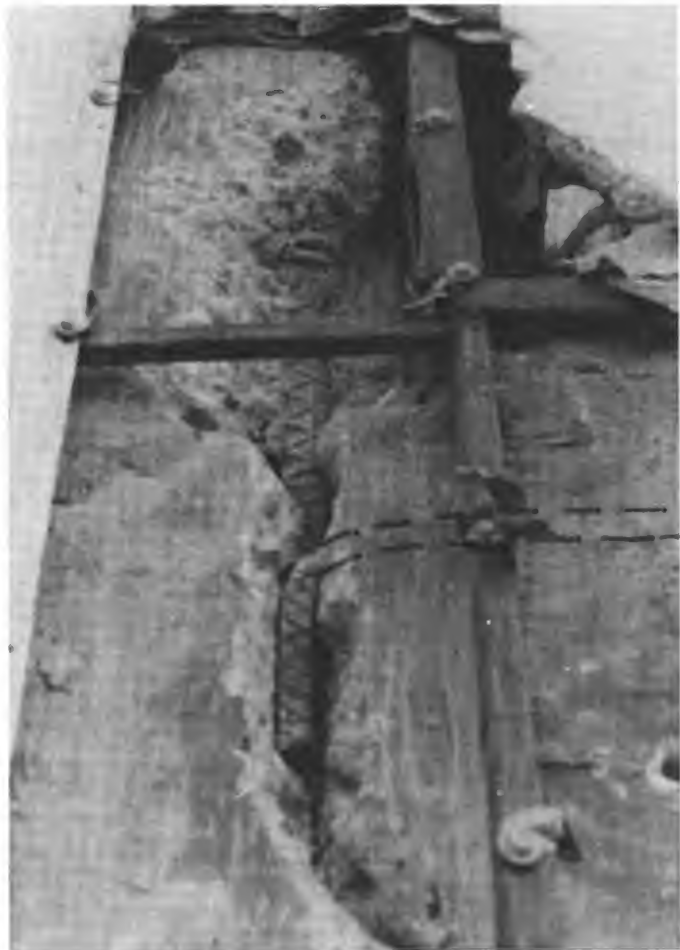
Figure 12.—Holiday Inn, Marengo Street. Closeup view of figure 11 showing exposed reinforcing bars at beam-column joint. General Adjustment Bureau photograph.
